Pre-Development Arboricultural Impact Assessment

Prepared For: **Dash Architects**
Site Location: **Unley High School, Kitchener Street, Netherby SA 5062**
Council Area: **City of Mitcham**
Date: **10 May 2023**

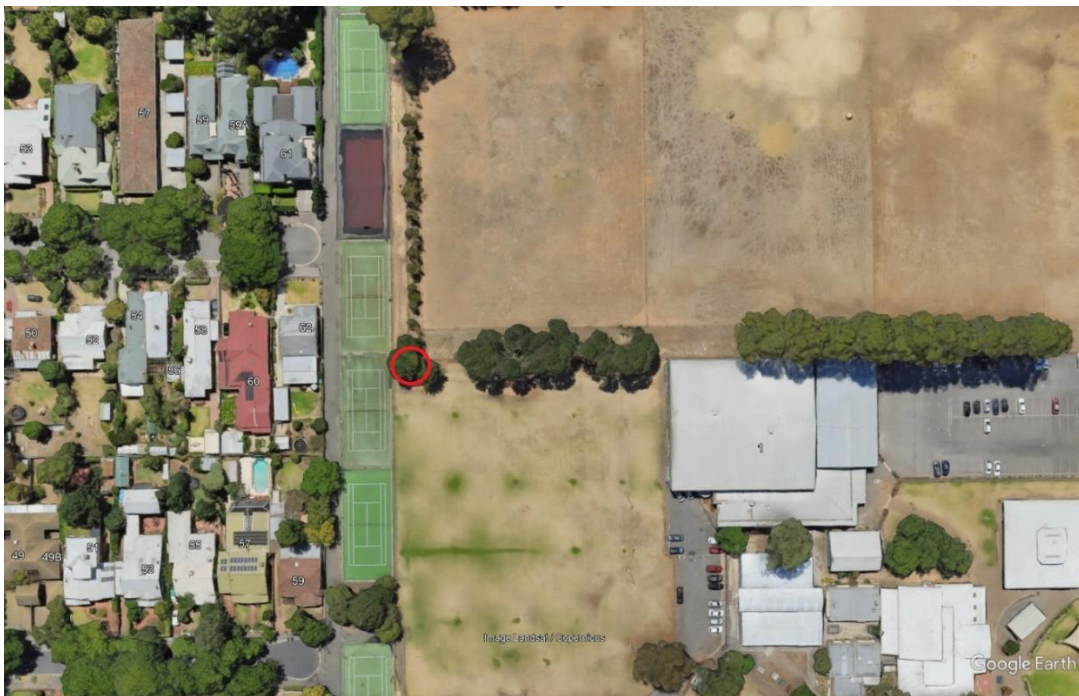
Figure 3 - shows an aerial image of the site subject to survey and assessment taken in 2018. The approximate location of the assessed tree is indicated in red.

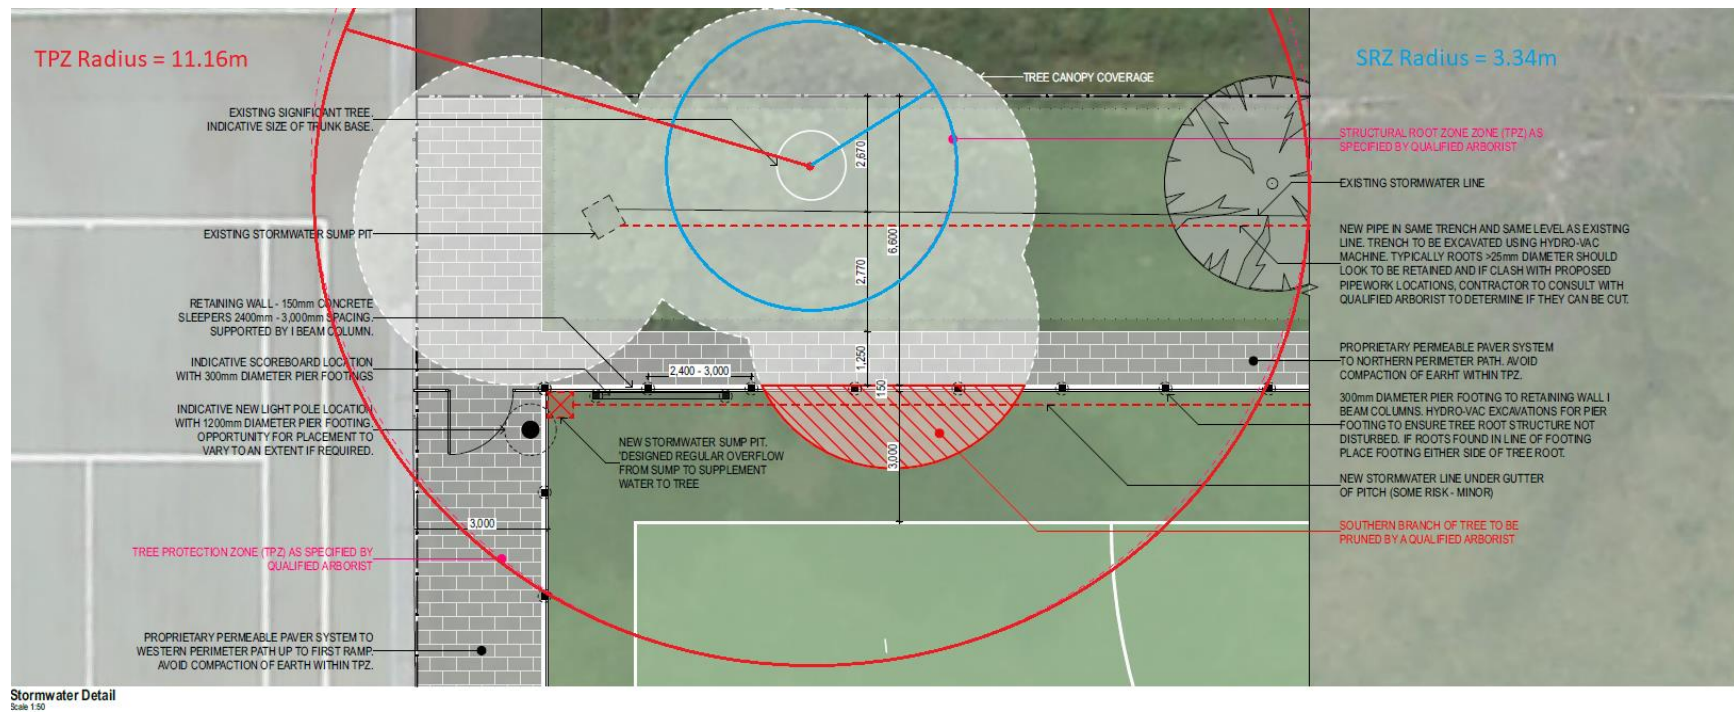
Tree No. 1
TPZ (radius)	11.16m
TPZ (area)	391 m ²
SRZ (radius)	3.34m

Tree Number	Encroachment Area (m2)	Encroachment Percentage	SRZ Encroachment
1	88m ²	23%	Yes

Part of the proposed footprint of the new pitch and associated retaining wall conflicts directly with the TPZ of the assessed tree. The calculations show an encroachment of 23% for the tree. This is a major encroachment under the terms and definitions within the standard and cannot be adequately compensated by offsetting the TPZ.

The diagram below shows the indicative Tree Protection Zones (TPZ) in red and the Structural Root Zones (SRZ) in blue of the assessed tree.

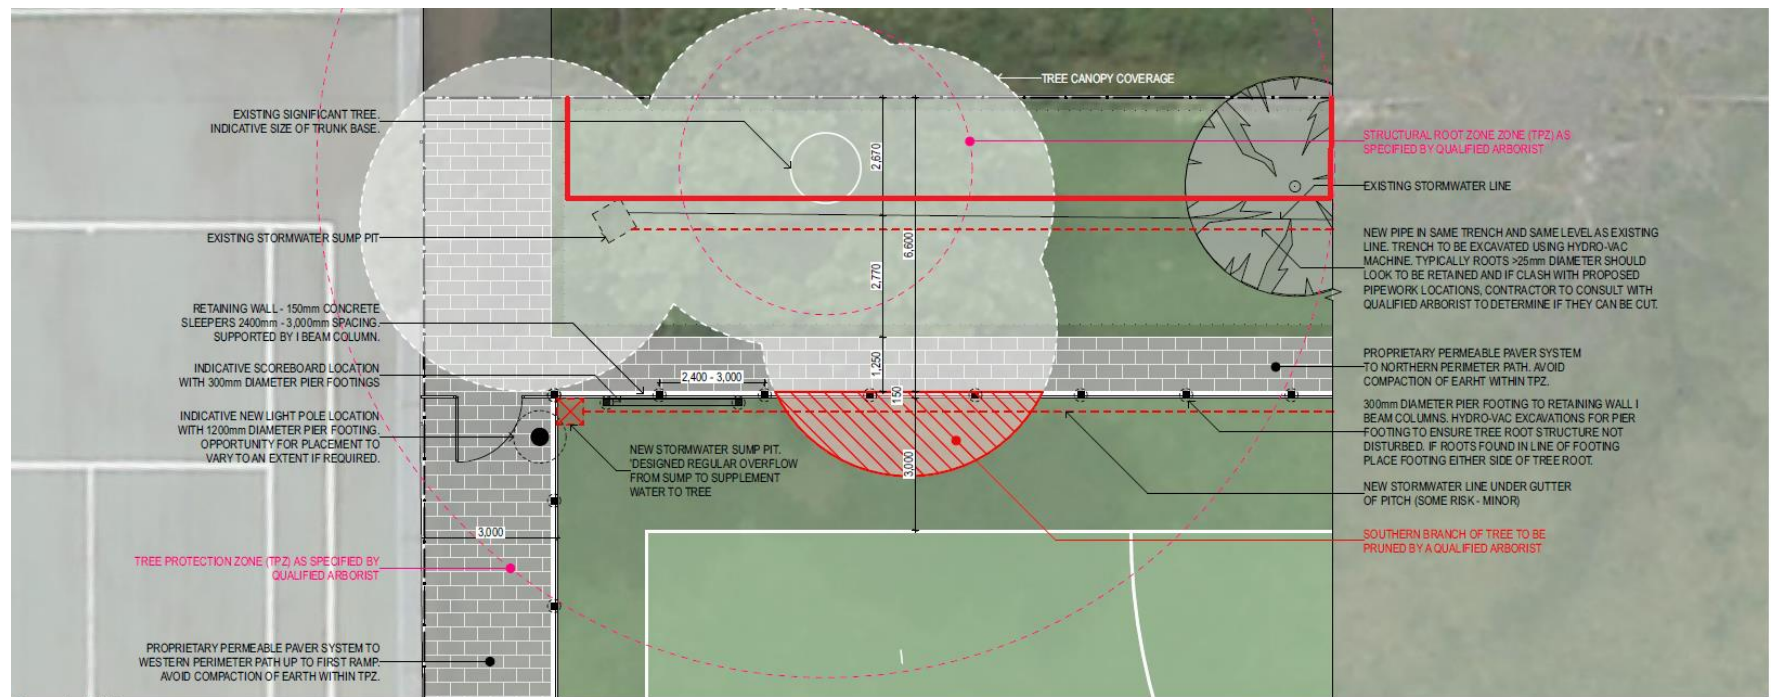
Stormwater Detail
Scale 1:50

An existing and proposed stormwater pipeline is located within the calculated SRZ at approximately 1.5m away from the tree to the south.

A proposed new stormwater sump and pipeline are proposed for within the new hockey pitch, where it is to be located within the designated TPZ. This is to be within the proposed fill material behind the retaining wall and as such will not require any direct excavation within the TPZ. The location of this new sump provides an opportunity to re-direct some of the collected stormwater

Where underground services or pipes are proposed to lay within the designated TPZ these are to avoid the SRZ completely and to be located as far away from the tree as possible. Any excavation trench is to be completed by hand or using a hydro-vac (on low pressure setting) to avoid the potential for damage to tree roots. Trenching works are to be completed under the direct supervision of the project arborist. In this instance a proposed new stormwater pipe is to be installed along the line and to the same depth as the existing stormwater pipe within the SRZ.
